UNITED STATES ENVIRONMENTAL PROTECTION AGENCY
REGION 1
1 Congress Street, Suite 1100
BOSTON, MA 02114-2023

Memorandum

Subject: Whitney Barrel Inspection, 256 Salem Street, Woburn, MA

FIGURES – EPA Inspection of Whitney Barrel Property, Woburn, MA

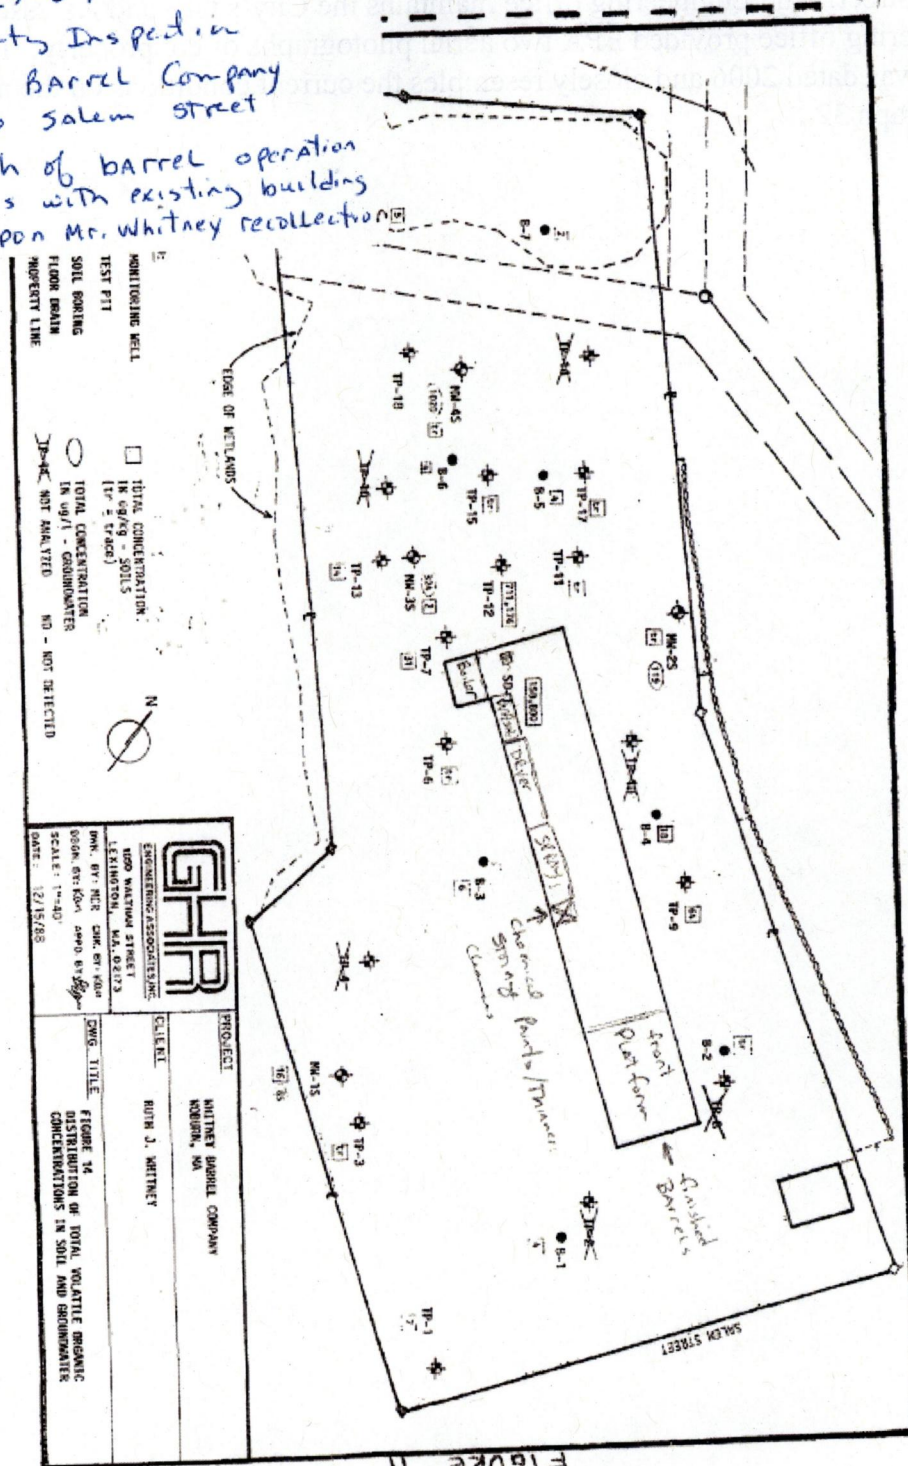
EPA sketch of barrel operation
Locations with existing building
Based upon Mr. Whitney recollection

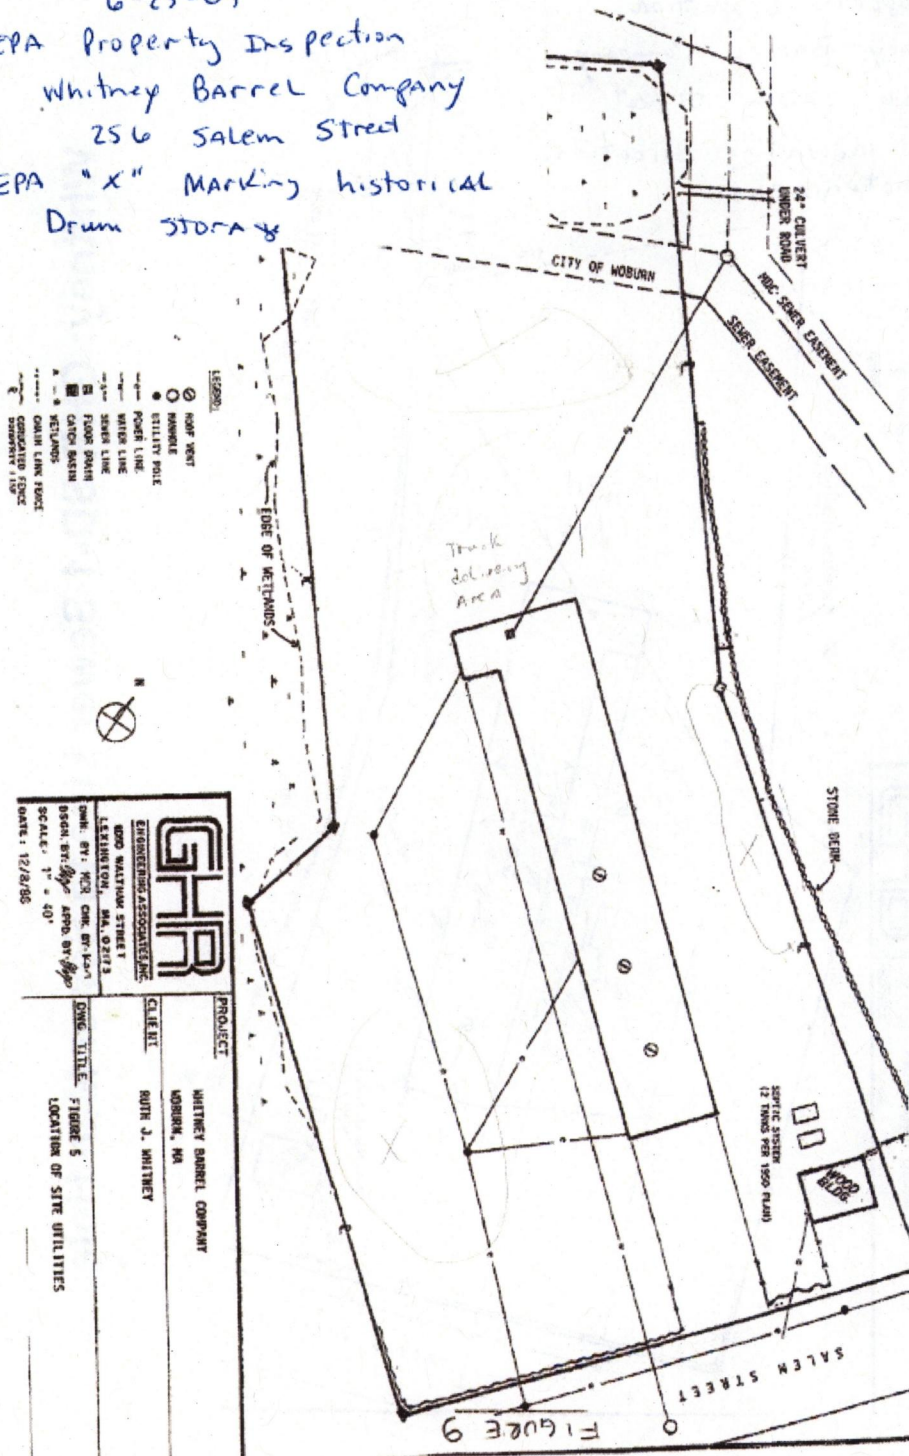
Mr. Whitney was asked where drums were stored outside the building. He indicated that drums were only stored at the northern portion of the property. He did not recall any drum storage to the east or west of the property. EPA illustrated some historical aerial photographs (see attached figures of 1969, 1971, 1981 and 1982) illustrating some drum and large storage containers along eastern and western portions of the property. Mr. Whitney acknowledged the photographs, but did not recall storing drums in those areas.

6-23-09
 EPA Property Inspection
 Whitney Barrel Company
 256 SALEM STREET
 EPA "X" MARKING historical
 Drum STORAGE

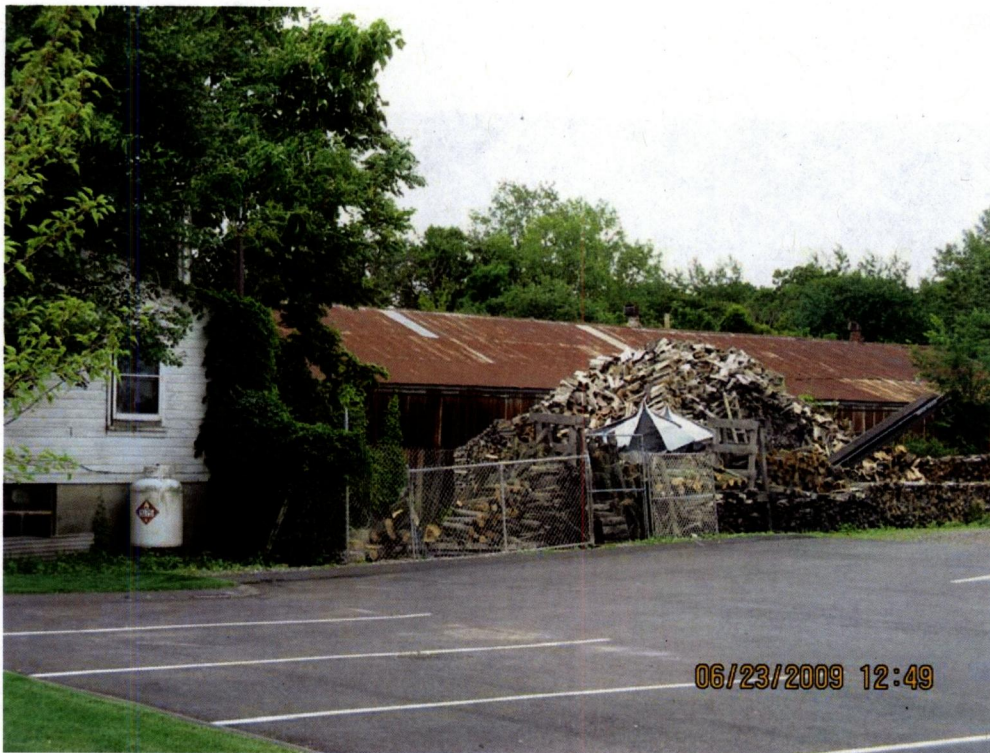
After our meeting inside the Wynn Trucking facility, we walked over to the Whitney Property for a tour/inspection. During the walk, EPA asked Mr. Whitney how many tenants he currently has on the property. Mr. Whitney stated approximately a dozen. He said most of them are associated with landscaping, tree service, and wood splitting businesses. See photograph 1.

1: The East side of Whitney Barrel as seen from Holland Arena

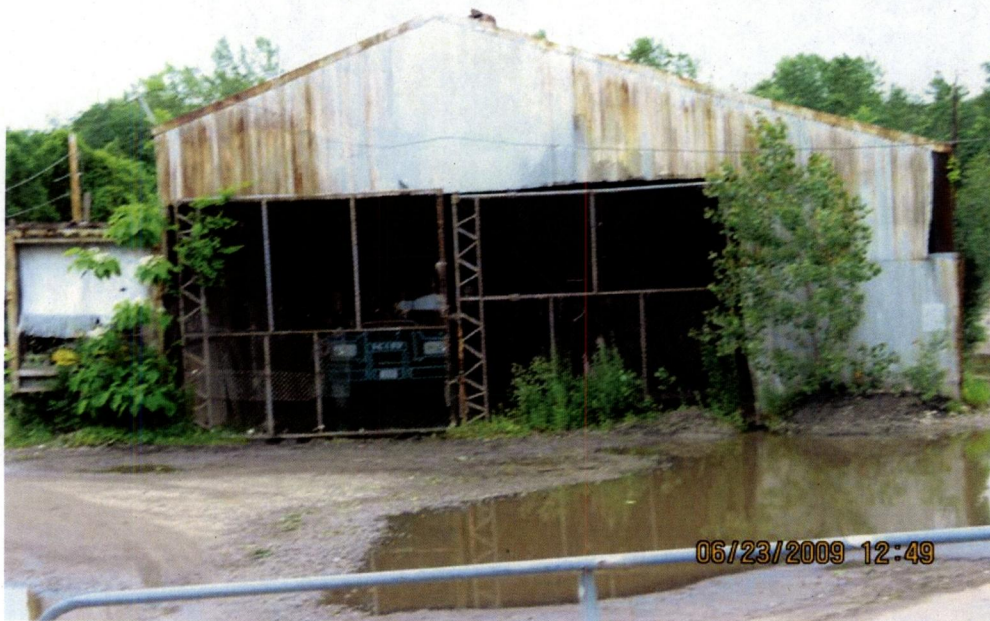
Entering the property from Salem Street, you observe the front platform area of the existing building. There is approximately a five foot drop in elevation from Salem Street as you enter the Whitney Barrel property. Large puddles of water surrounded the southern portion of the building and extended around to the east side of the building. These large puddles were likely due to recent rain events and poor drainage on the property. Mr. Whitney did not have a key to unlock the gate to the front platform. Looking through the chain link gate, the floor appeared to be earthen. There was another room towards the back (north). The floor of this back room was elevated approximately one foot above the ground and constructed of wood. This back room also contained some drums, which were visible from the gate at the entrance of the front platform. See photographs 2 and 3.

2: The South side of Whitney Barrel as seen from Salem St. (former front platform)

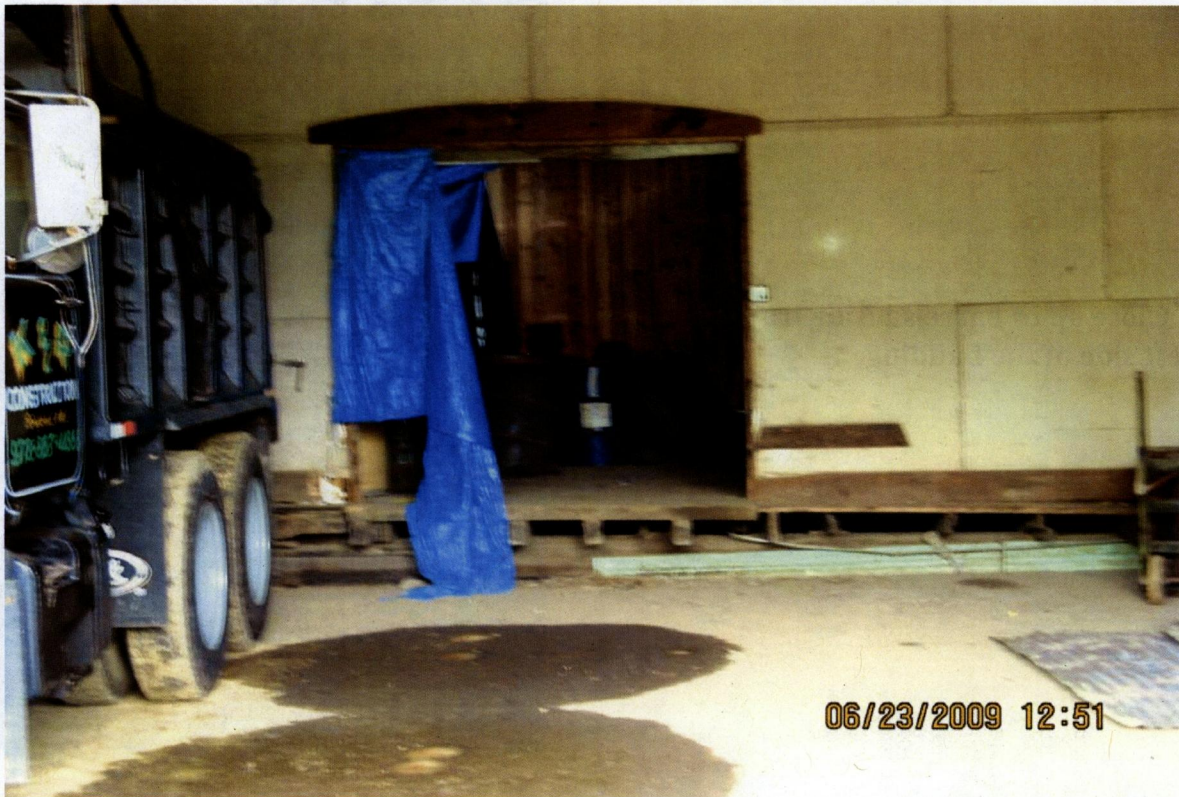
3: The Interior of Whitney Barrel from the south entrance (former front platform)

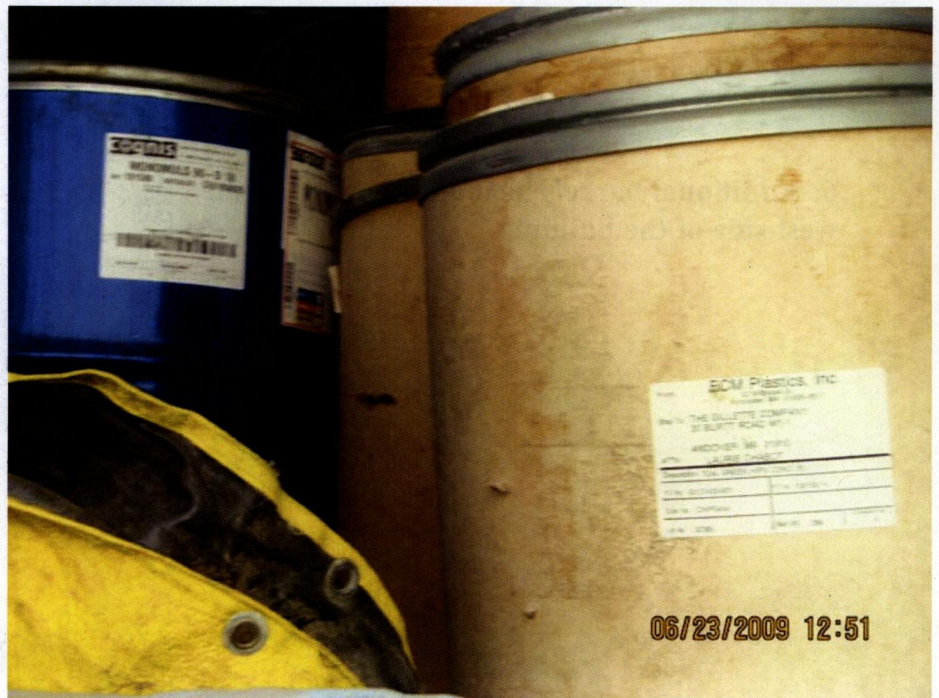
Outside the existing building by the southwest corner, there were a few trailers containing various drums. Mr. Whitney said that all the drums were empty. Various photographs were taken of the drums (e.g. Gillette, Ciba, Cognis, ECM Plastics, etc.). EPA also asked Mr. Whitney if he had any Underground Storage Tanks (USTs) on the property (such as USTs for gas or diesel which may have been used to fuel delivery trucks). Mr. Whitney said he had received the appropriate permits to install USTs, but never had the USTs installed on the property. EPA asked what type of fuel powered the boiler in the former boiler room. Mr. Whitney said oil. EPA asked how the oil was stored. Mr. Whitney said

4: Barrels inside trailers located on the west side of the building

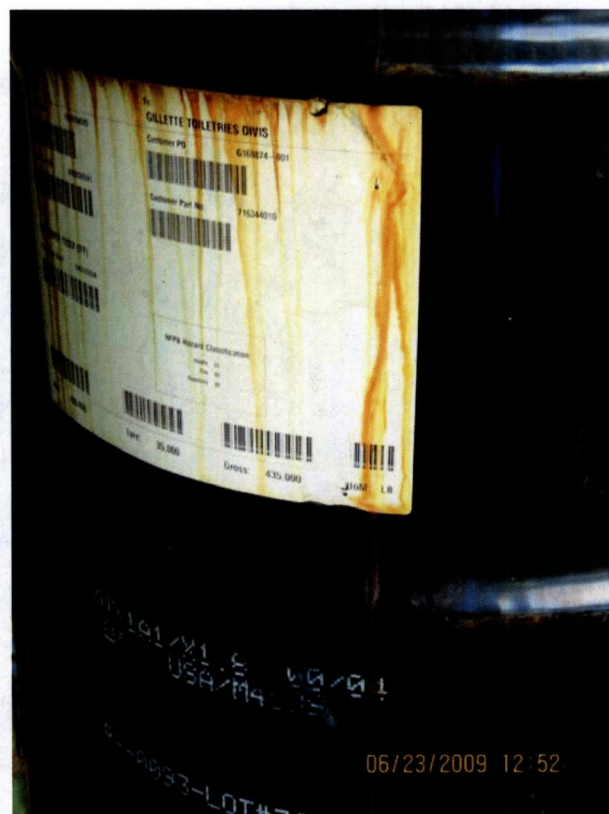
5: Close up of barrels inside trailers on the west side of the building

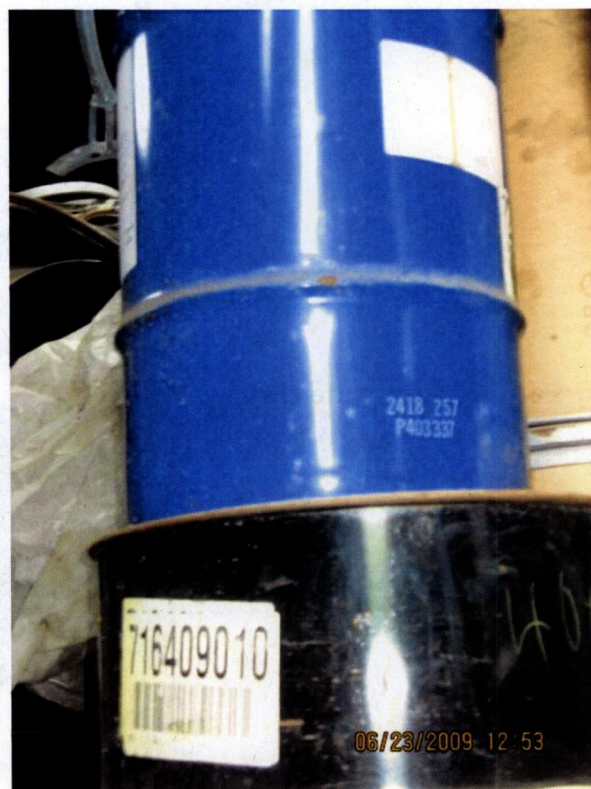
6: Additional barrels inside trailers along the west side of the building

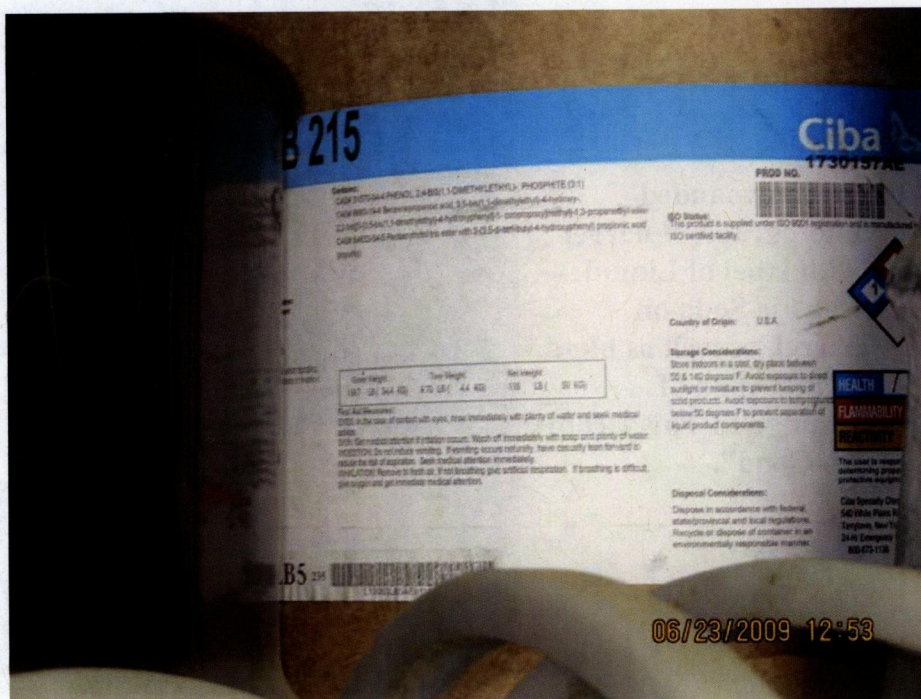
7: A close up of a label on barrel inside trailer on the west side of building

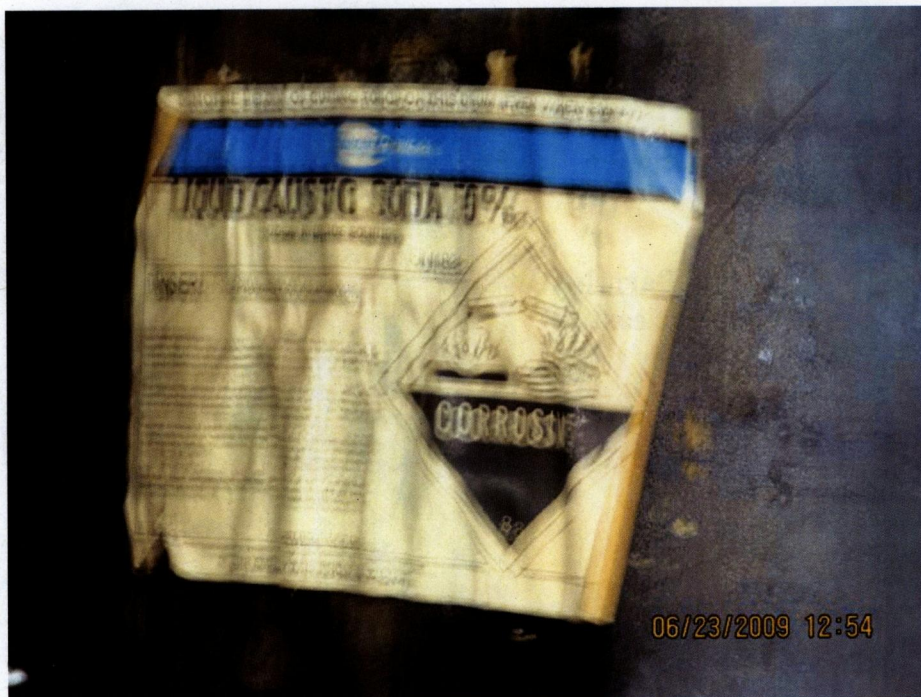
8: A label of liquid Caustic Soda on a barrel inside a trailer along the west side of the building

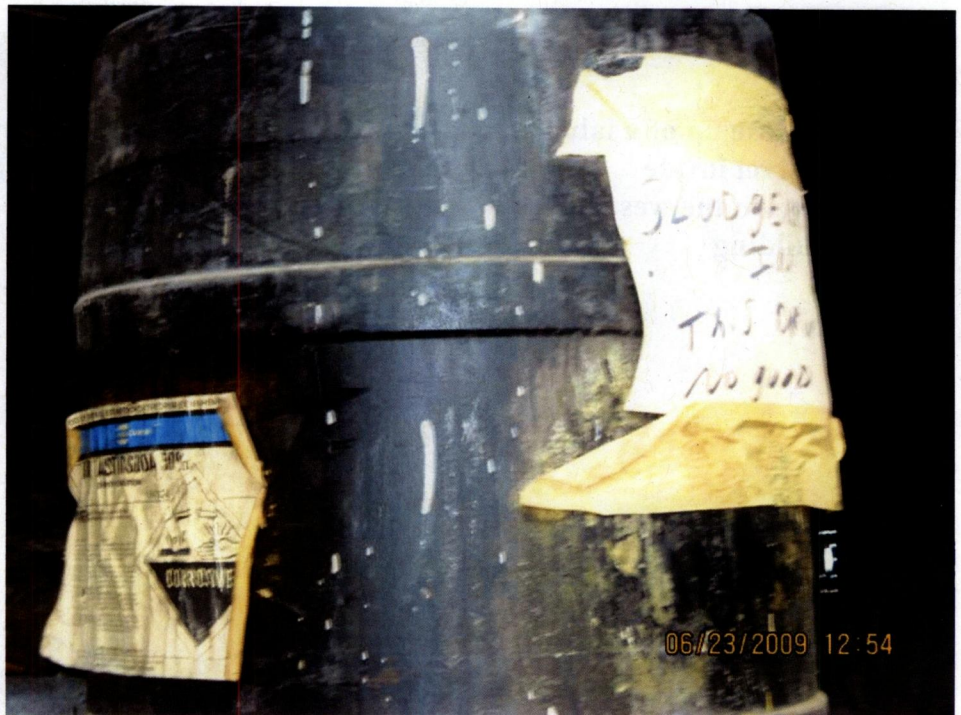
9: An expanded photograph of barrel with label of Liquid Caustic Soda on barrel, as well as hand written sign of "Sludge In This Drum No Good".

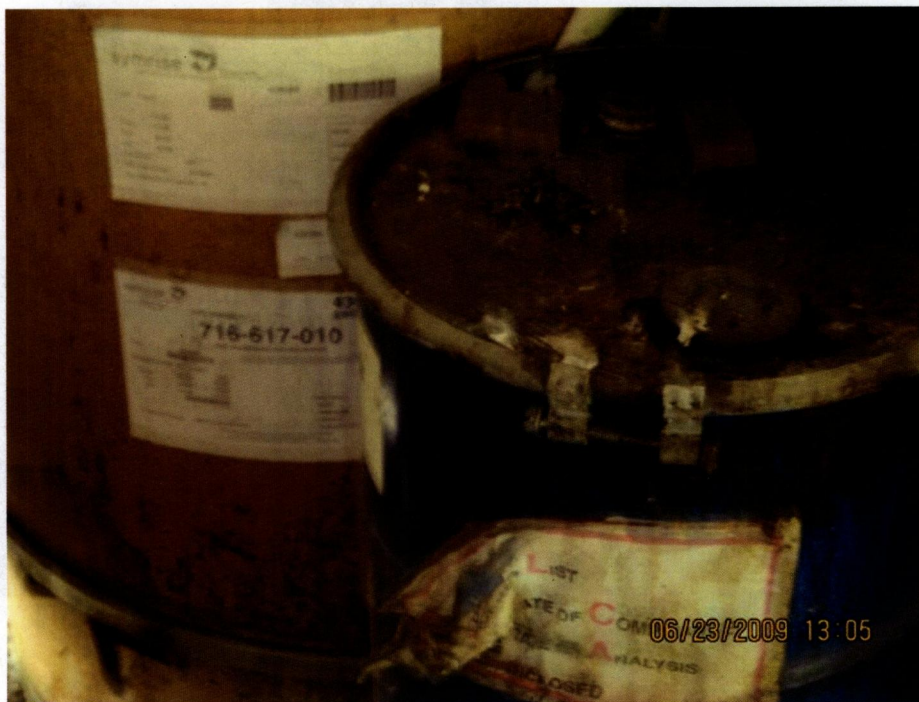
11: The same barrels with more visible labels

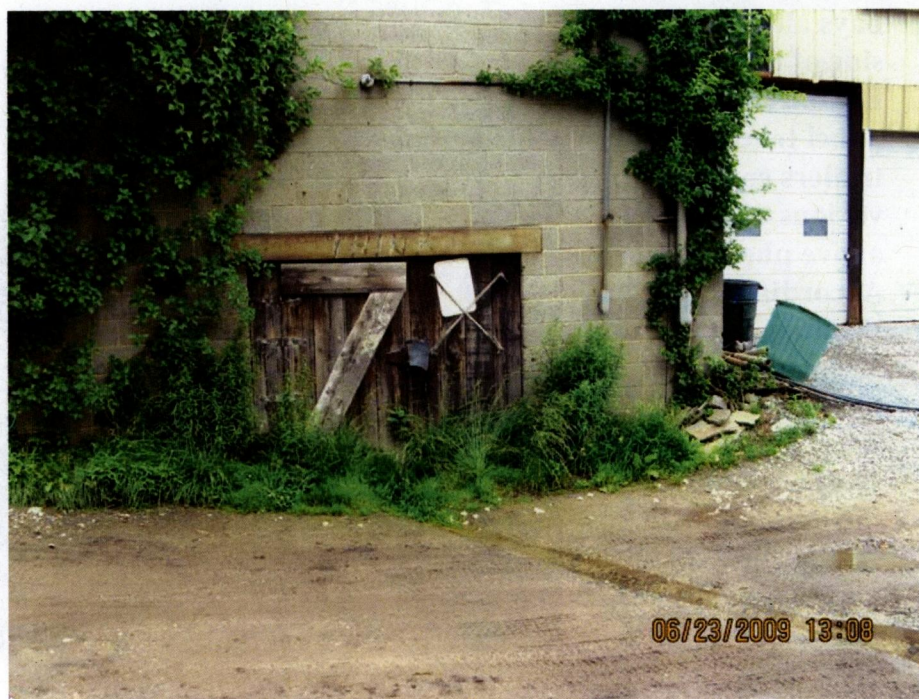
EPA met an occupant of the property, Mr. Hans Christian Anderson (Mr. Anderson lives in a trailer on the property). Mr. Anderson had a key to the boiler room, and unlocked the door for EPA to inspect the boiler room. As mentioned previously, the floor consisted of broken up stone and soil. It was very muddy and musty inside. Some surface water was inside the room. Portions of the surface water entered the room from the south, exited the room to the west, and discharged into a portion of the Murphy Wetland. The boiler and oil tank appeared to have been removed long ago from the room. There were windows on the south and north side of the room and concrete block wall to the east (there was no connection to the existing northern building – although, uncertain what the access conditions were in the original building prior to northern building being constructed in 1978). Currently, the boiler room was used for storage by Mr. Anderson. It did not look like things have been moved around the boiler room for some time. Much of the metal items within the room were rusted. A couple of four-draw metal filing cabinets were inside being used as table legs. The draws did not appear to

12: Former Boiler Room situated in the northeast corner of the building, with standing water leading from the door and flowing west to the Murphy Wetland.

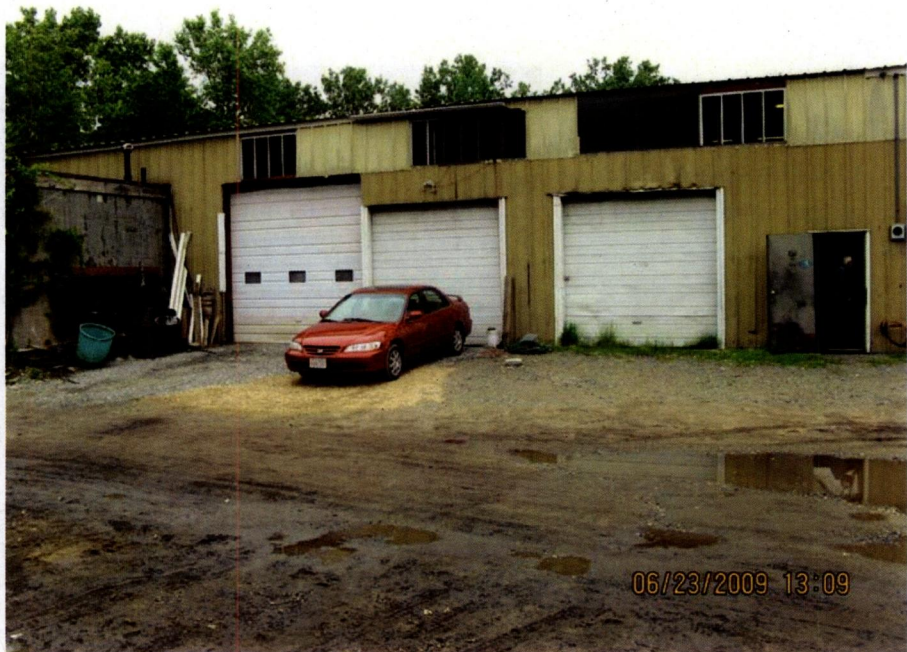
13. Garage bay along the west side of the building, just south of Boiler Room. The foundation in this northern portion of the building contains a concrete slab and foundation (100' x 40').

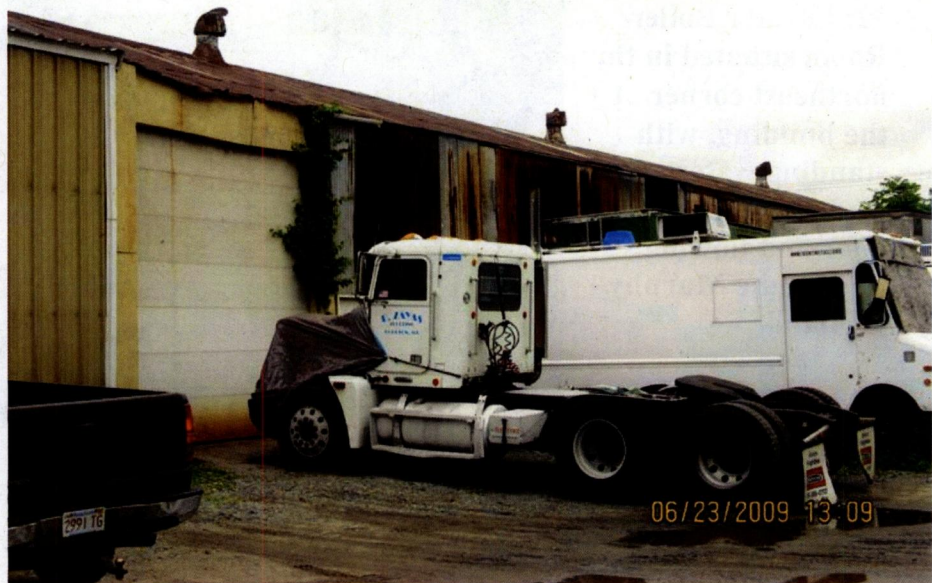
EPA met a tenant to the southern portion of the building (rusted sheet metal exterior and roof on aerial photographs). The tenant, who also worked on antique cars, allowed us to enter his section of the building. This section of the southern portion of the building contained a plywood floor attached to some form of wood frame. The wood frame appeared to be directly on top of the ground. The plywood flooring inside the building was very wavy, suggesting that some of the wood frame was rotted (likely compounded by moisture and standing water observed under the building, and poor drainage on the property). Mr. Whitney stated some other tenant installed the plywood flooring. The siding and roof were constructed with sheet metal. Some of the roof vents were visible from inside this section, along with a hole in the west side of the building where some corrugated sheet metal was missing. Six drums were observed along the floor at the east side of building. The tenant said the drums were empty. According to the tenant, the drums were obtained from the property (owned by Whitney) and periodically used by the tenant for storing waste oil. See photographs 14, and 18-23.

14. Trucks and additional garage bays along the west side of the building. Behind the white panel truck are 3 trailers containing various drums (see above photographs). According to Mr. Whitney, all drums are empty. The photograph also illustrates the southern portion of the building with rusted sheet metal and roof vents, and containing a plywood floor.

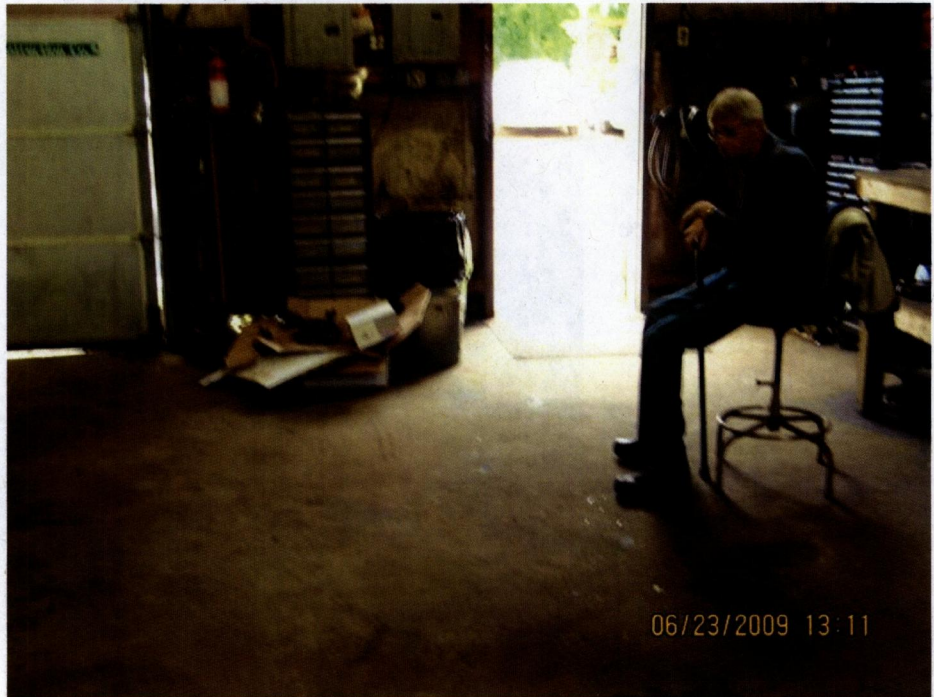
15. Interior of the west side of the building (inside one of the garage bays). The floor is a concrete slab connected to a concrete foundation along the exterior walls.

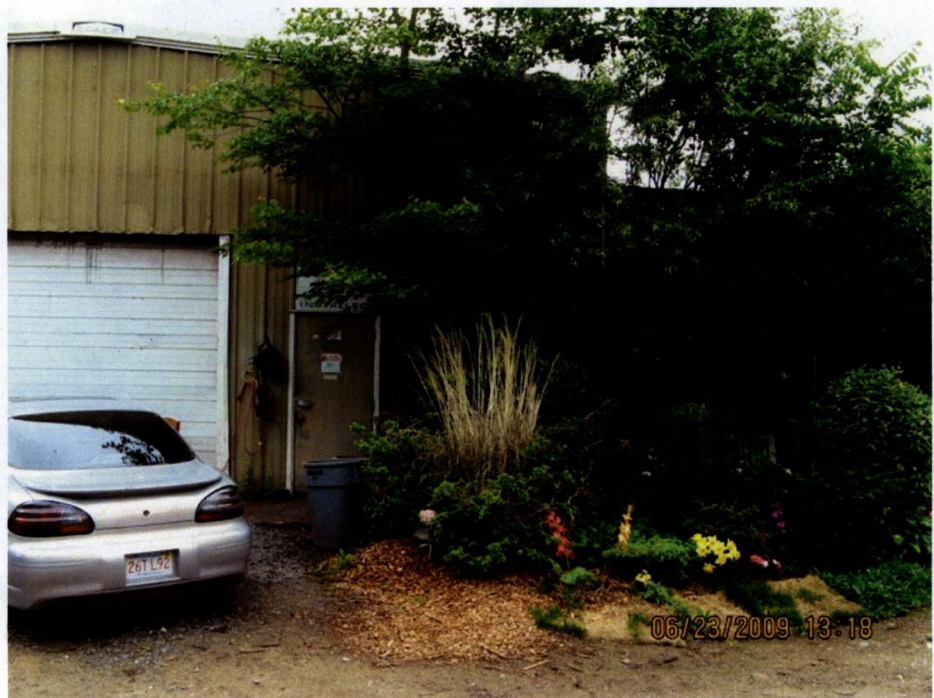
EPA asked Mr. Whitney if he had keys to the most northern portion of the building, where drums historically entered the building. Mr. Whitney said he did not. Mr. Whitney said the area is identical to this one (same concrete floor). EPA asked if the historical sewer catch basin was still present in this most northern portion of the building. Mr. Whitney said the sewer was filled with concrete, and you can no longer see it (looks the same as the concrete floor). Mr. Whitney also said that this most northern portion of the building did not contain electrical power. According to Mr. Whitney and another tenant, a landscaping company rents this most northern section of the building and stores landscaping equipment. See photographs 16 and 17.

16. The exterior of the north side of the building. The boiler room is to the right (west) extending off the building and hidden behind some vegetation. Historically, this garage door bay was where drums were brought into the building to be cleaned.

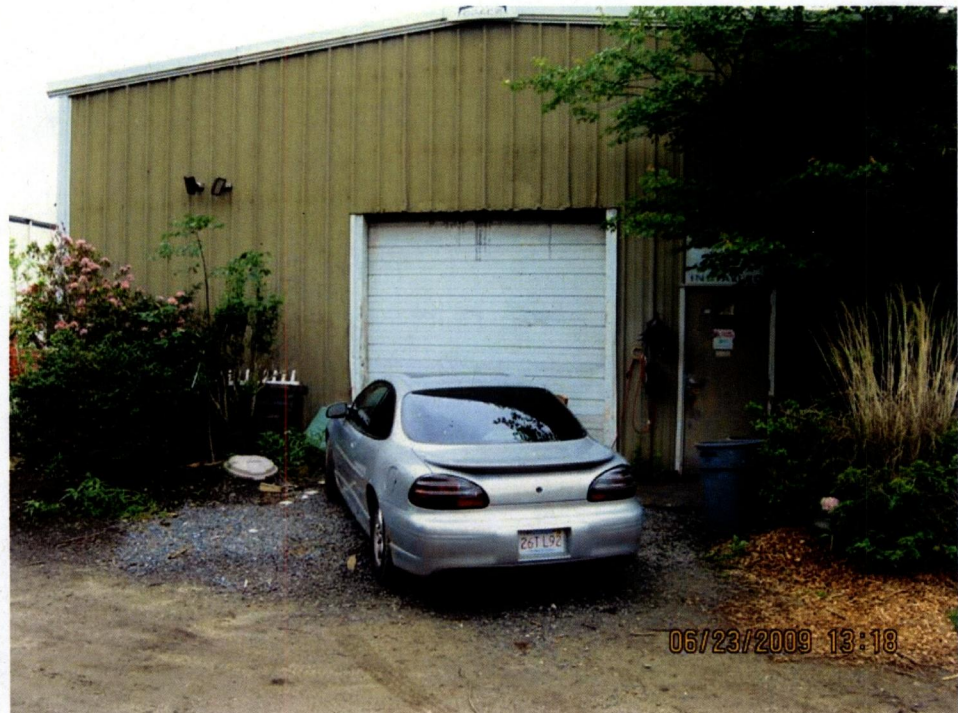
17. Garage bay at the north side of the building. This garage bay was where drums were historically brought into the building to be cleaned.

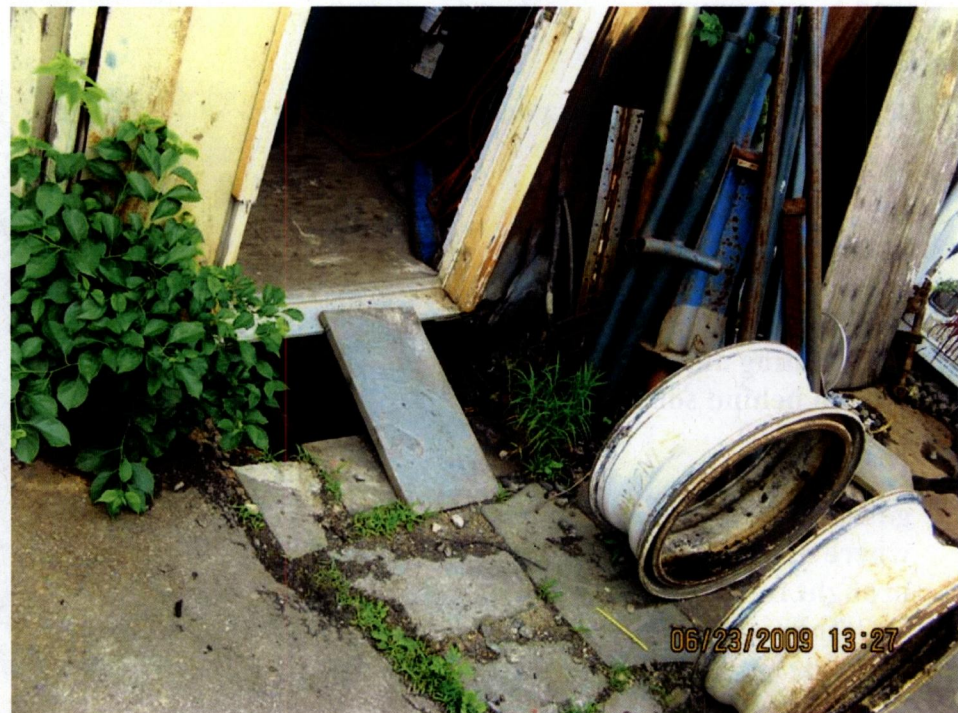
18. A doorway on the west side of the southern portion of the building showing gap in foundation. The foundation appears to be on the ground.

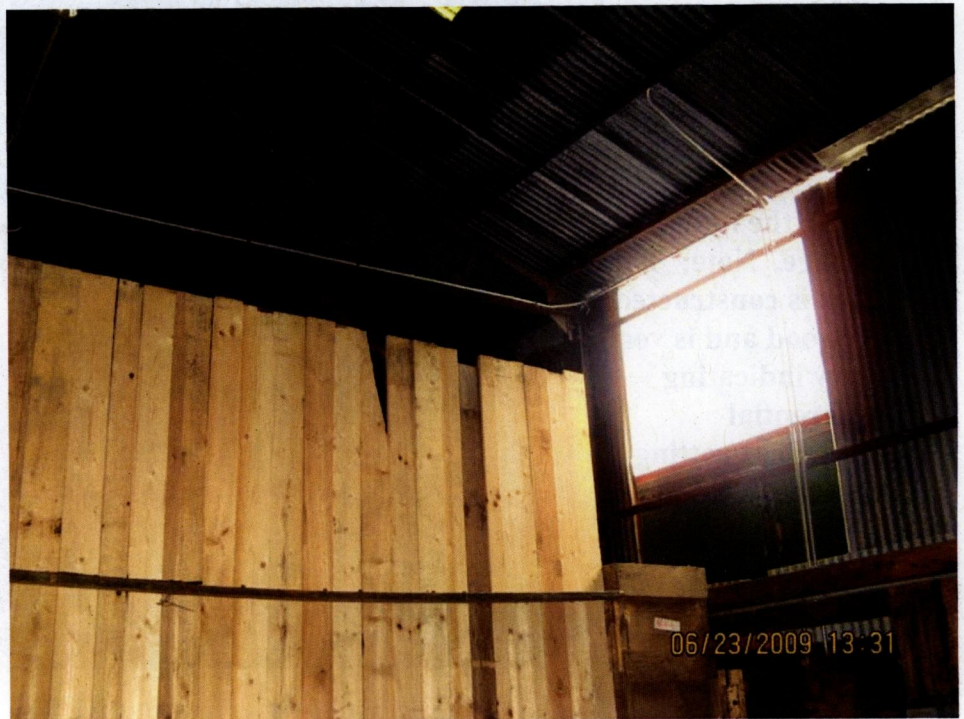
19. The interior of the southern portion of the building facing south. The southern interior was divided with wooden planks (separating it from the southern entrance of the building). Sheet metal is missing along the west side of the southern portion of the building.

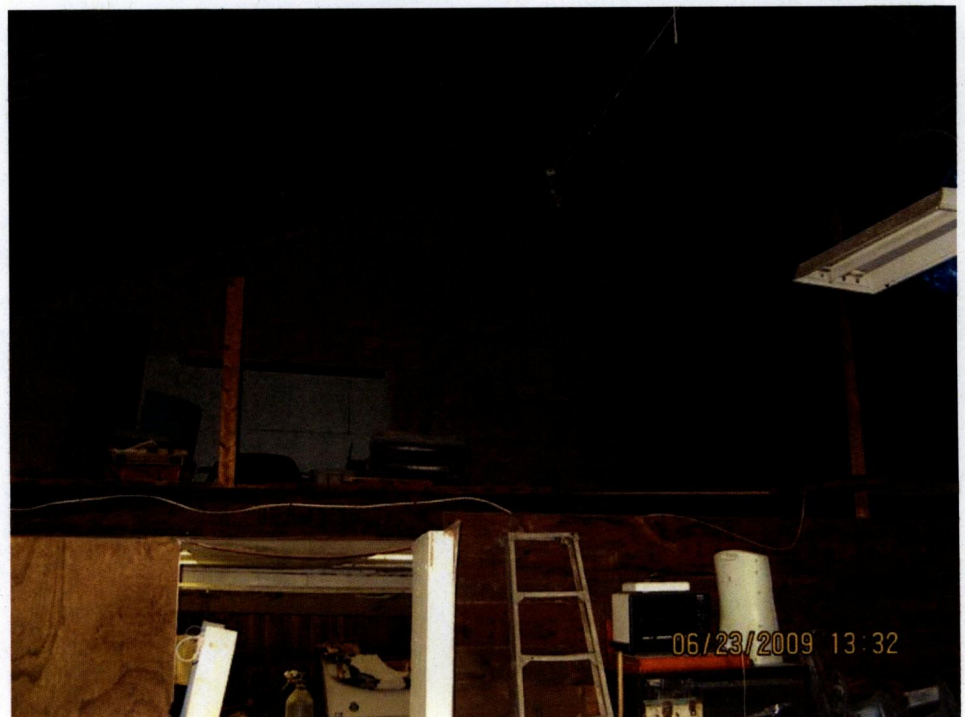
20. The interior of the southern portion of the building facing north, showing a lofted storage area

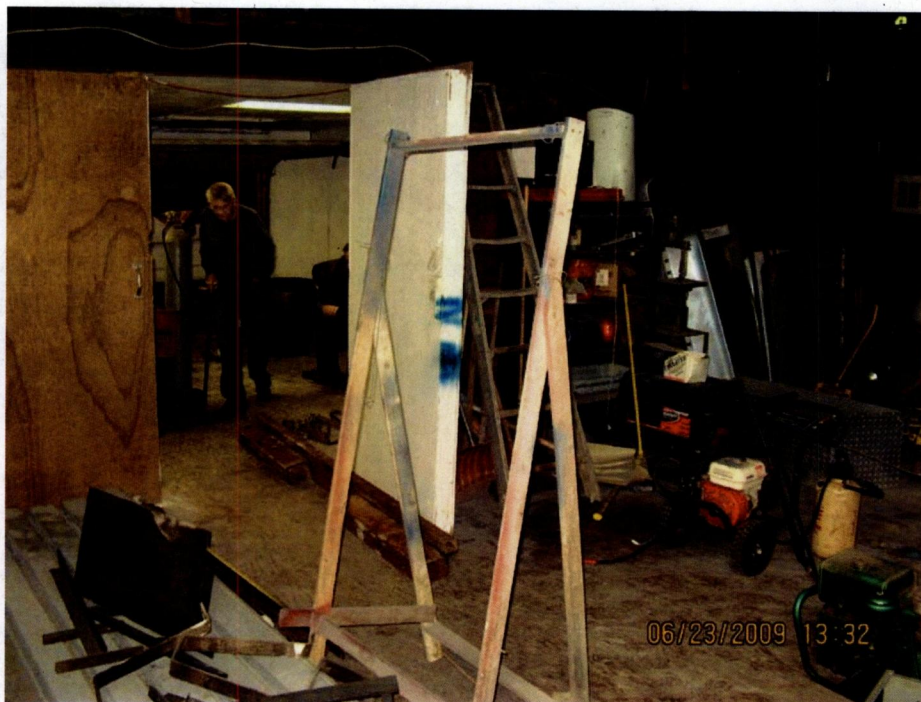
21. The interior of the building facing north, showing work area under the lofted storage. Note: The floor is constructed of plywood and is very wavy indicating differential settlement/rotting wood.

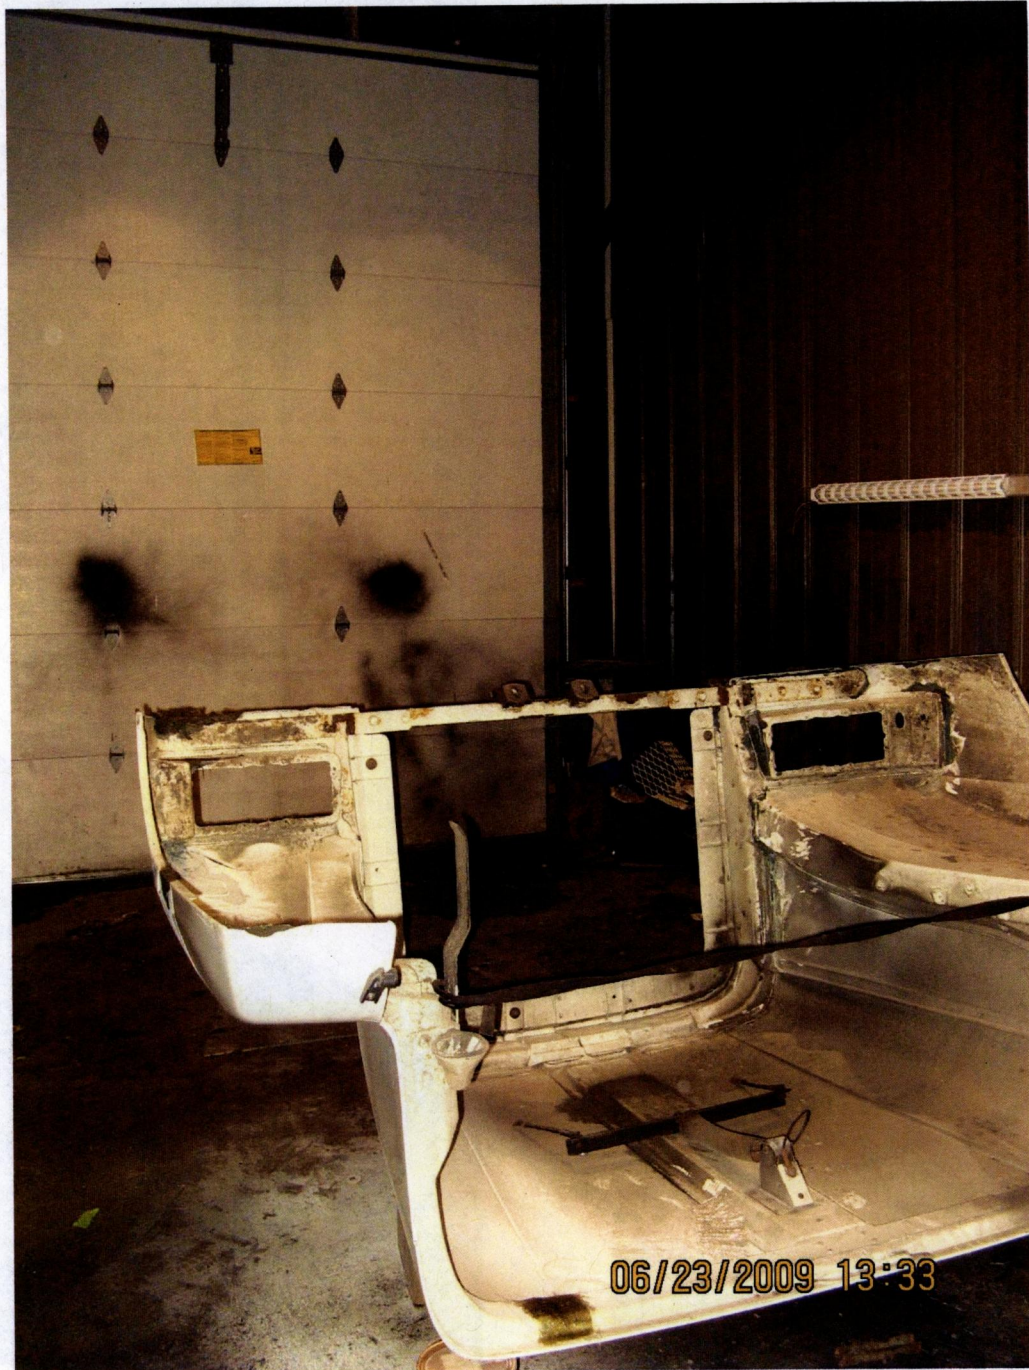
22. A garage bay door on the west side of the southern portion of the building. The hood of a truck is on the plywood floor.

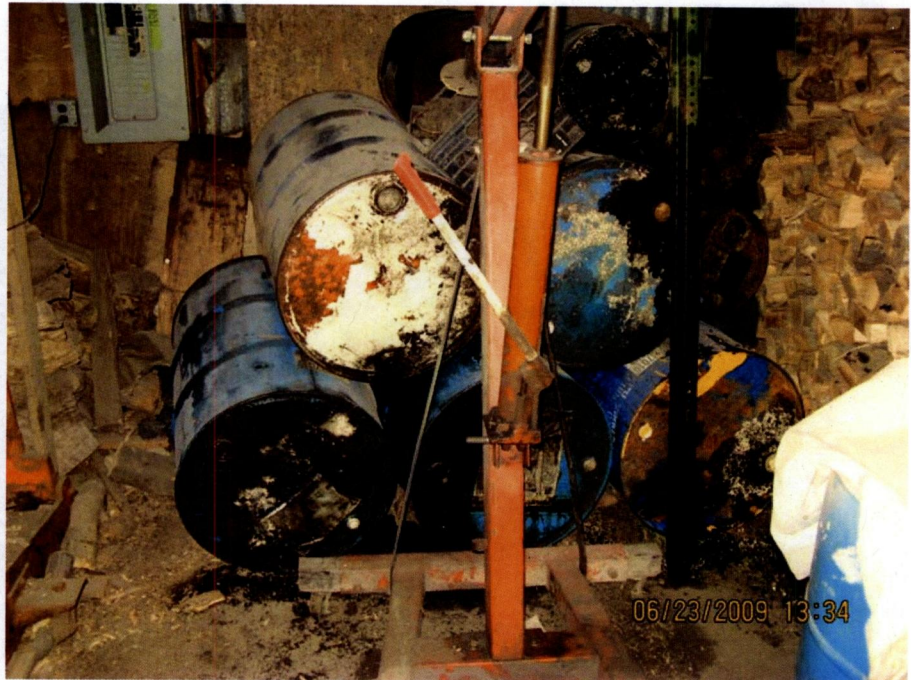
23. Decaying barrels stored along the interior of the east side of the southern portion of the building. Lessee suggested the barrels belonged to Mr. Whitney (obtained from the property), but he used them for storing waste oil. According to the lessee, the barrels were currently empty.

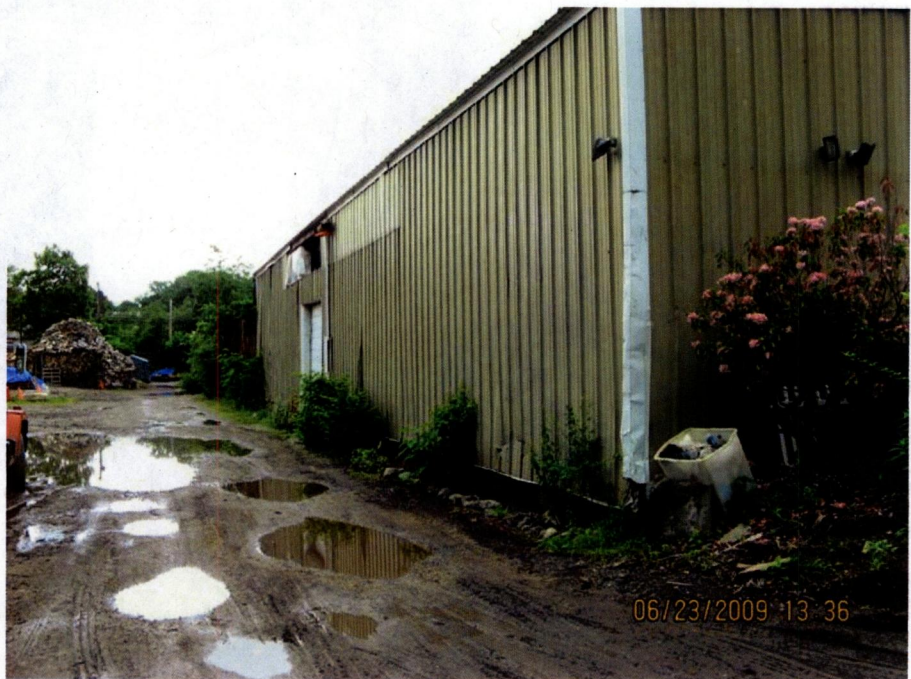
EPA walked along the east side of the building. Since construction of the adjacent hockey rink, it appears Mr. Whitney has removed some vehicles/equipment/ trailers from this area. There were a few piles of dirt/debris, but generally this east side was clearer than it has ever been in the past. Surface water was observed pooled against and under sections of the southern portion of the building (rusted sheet metal exterior). Looking through holes in the sheet metal at the ground underneath the plywood flooring, surface water was observed standing under the building. See photographs 24-31.

24. The exterior east wall of the building, facing south. Painted sheet piling exterior denotes northern portion of building with concrete slab and foundation.

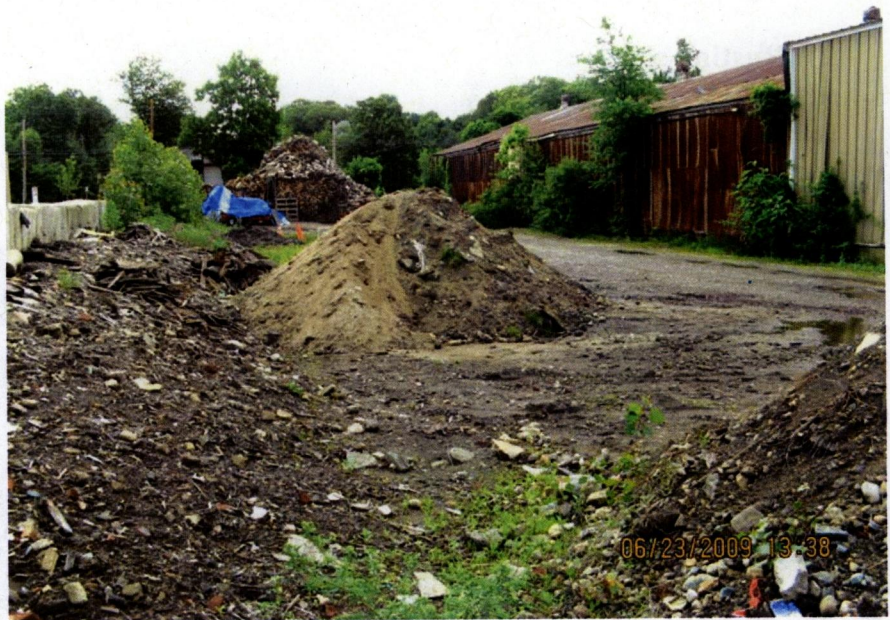
25. Piles of debris along the eastern edge of the property. It appears much of the historical debris, equipment and vehicles from this east side of the property have been removed over the past couple of years. Rusty sheet piling exterior denotes southern portion of building with plywood flooring and likely earthen foundation.

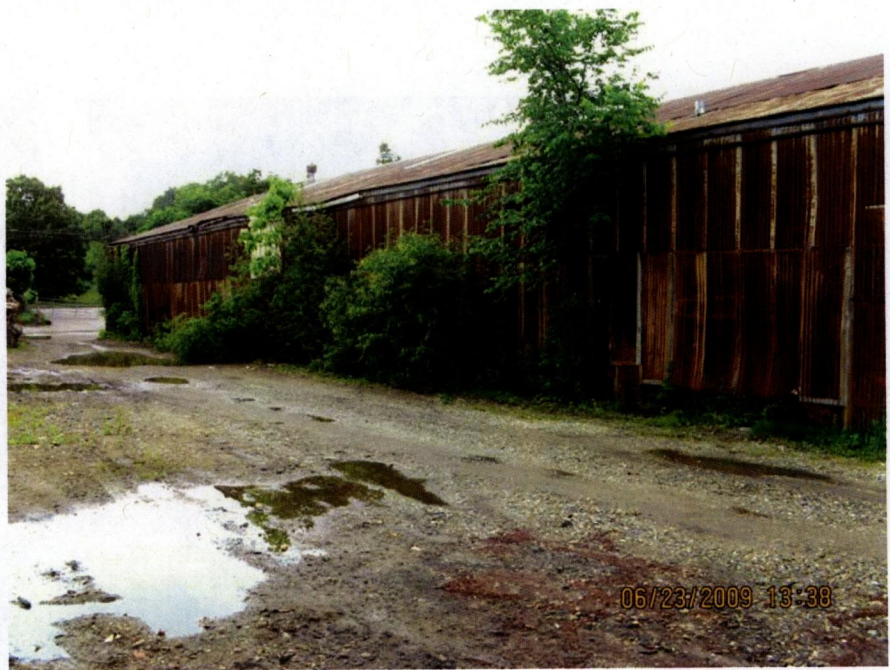
26. Rusting corrugated sheet metal that makes up the eastern wall of the southern portion of the building. The foundation is exposed in areas where sheet metal does not extend to the ground. In these exposed areas water is pooled under the building (see photographs below).

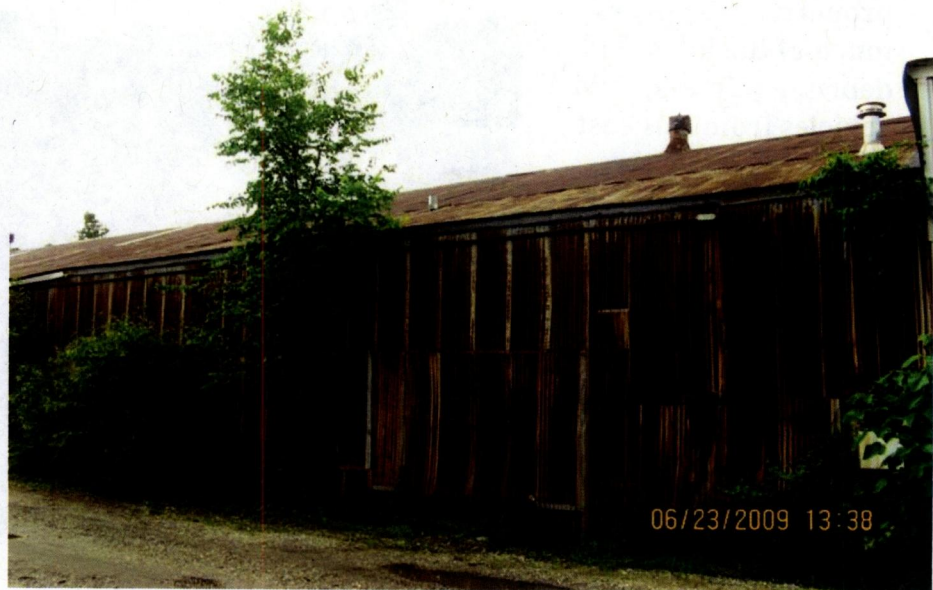
27. Rusting sheet metal exterior of the southern portion of the building, as well as various roof vents and holes in the bottom sheet metal exposing areas of the foundation.
